Hydrogen peroxide vapour material compatibility: Issues and facts for Bioquell technology

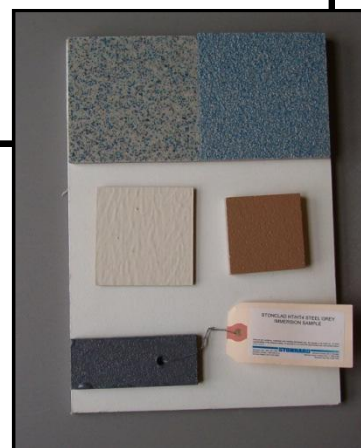
Material	Ceramic tiles
Description	Five STONHARD ceramic tiles, used for wall and flooring were tested (as pictured, below)
Observations	None of the tiles showed any signs deterioration or visible deposits on the surfaces
Conclusions	Hydrogen peroxide vapour has no apparent effect on ceramic tiles.
Recommendations	Ceramic tiles are recommended as suitable materials in a room regularly decontaminated by hydrogen peroxide vapour.
Method of testing	<p>A Clarus R generator was placed inside a room of approximately 30m³. The ceramic tiles were placed inside the room.</p> <p>The enclosure was sealed and samples were subjected to 85 back-to-back cycles. A typical cycle achieved a concentration of >500ppm for 32 minutes, thus the samples were subjected to >500ppm for 43 hours. The samples were then removed and inspected.</p> <p>The inspection consisted of a detailed visual inspection and a mechanical inspection to ascertain whether the material had been adversely affected during the exposure.</p>

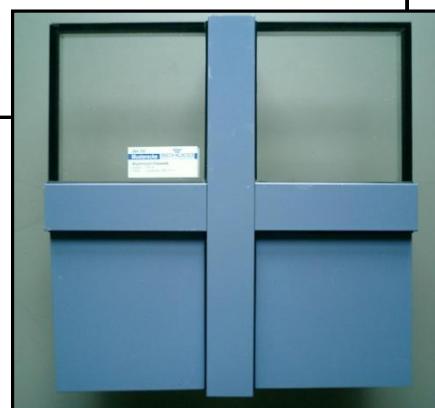
Material	Window frame (double glazed)
Description	Two double glazed plastic window panes and their associated coated aluminium frame (as pictured, below)
Observations	Neither the plastic windows nor the frame showed any signs deterioration or visible deposits on the surfaces. No glazing was evident on the window panes.
Conclusions	Hydrogen peroxide vapour has no apparent effect on double glazed windows or frames.
Recommendations	Double glazed windows are recommended as suitable materials in a room regularly decontaminated by hydrogen peroxide vapour.
Method of testing	<p>A Clarus R generator was placed inside a room of approximately 30m³. The window frame was placed inside the room.</p> <p>The enclosure was sealed and the sample was subjected to 64 back-to-back cycles. A typical cycle achieved a concentration of >500ppm for 30 minutes, thus the sample was subjected to >500ppm for 32 hours. The samples were then removed and inspected.</p> <p>The inspection consisted of a detailed visual inspection and a mechanical inspection to ascertain whether the material had been adversely affected during the exposure.</p>

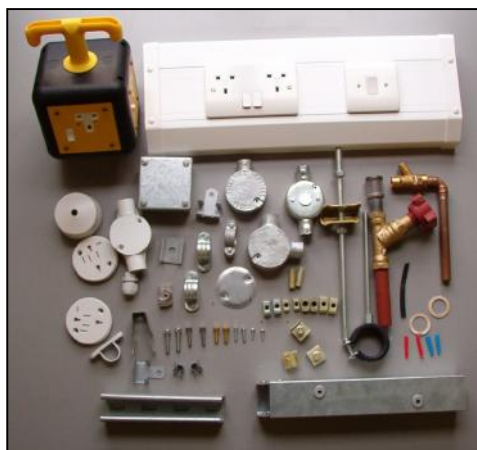
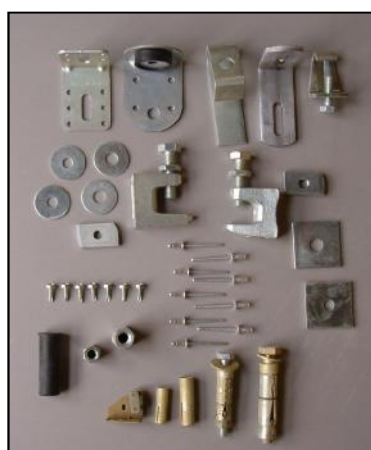
The materials tested are pictured below:

Passivated (coated) metal materials showed a slight discolouration. This is shown by the face on which the component has been resting still has a shiny finish whilst the exposed sides have lost their glossy finishes. Similarly, discolouration of copper was noted. These purely aesthetic changes are due to the strong oxidising properties of hydrogen peroxide vapour.

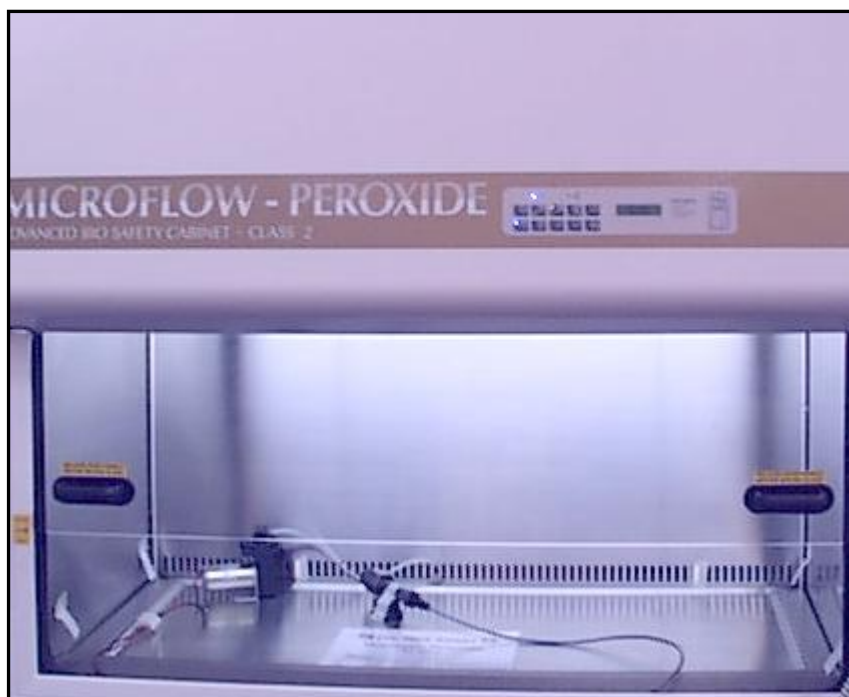
Corrosion testing

860 gassing cycles over a 4 month period

- No electronic failures
- Electrical wiring undamaged
- Stainless steel unaffected
- Painted mild steel unchanged
- Exposed PCB not damaged

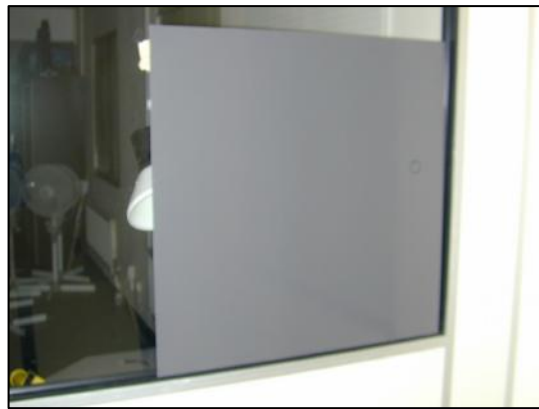
No.1 (galvanised steel with undercoat and topcoat) before and after gassing

(a) Before

(b) After

The trade paint does bubble around the edges when subjected to multiple hydrogen peroxide vapour exposures. The bubbling was not apparent on the flat painted surfaces of the materials. This provides evidence that the bubbling is caused by hydrogen peroxide vapour diffusing under the painted surface at the edges, decomposing to liberate oxygen and hence causing an expansion effect on the paint surface. Bubbling was much more prevalent on the galvanised steel substrate than the mild steel. This would lead to the conclusion that there is a better adherence of the paint to the mild steel than the galvanised steel, limiting the diffusion of the hydrogen peroxide into the paint.

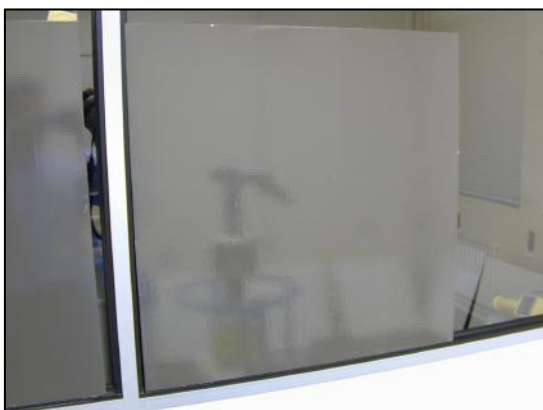
No.2 (galvanised steel with undercoat, topcoat and varnish) before and after gassing

No bubbling was witnessed on this substrate / paint combination

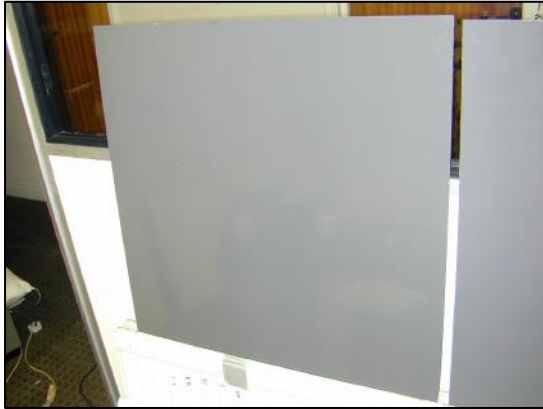
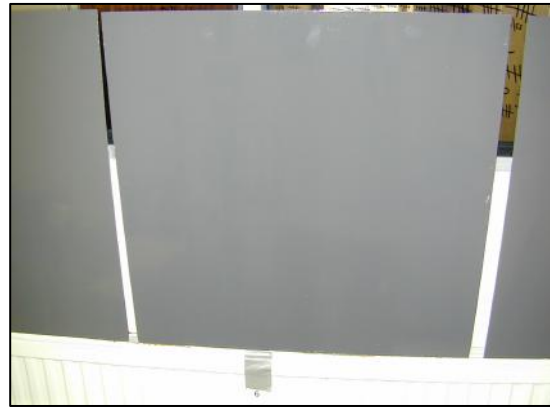
No.3 (mild steel with undercoat and topcoat) before and after gassing

(a) Before

(b) After

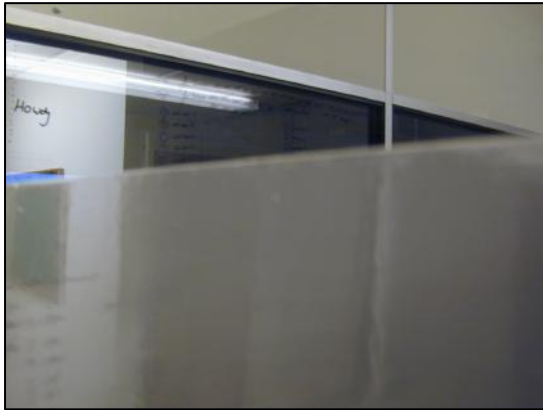
(c) (left) Close-up of bubbling on the edge of the paint sample. Bubbling was extremely fine – very hard to pick up with a camera.

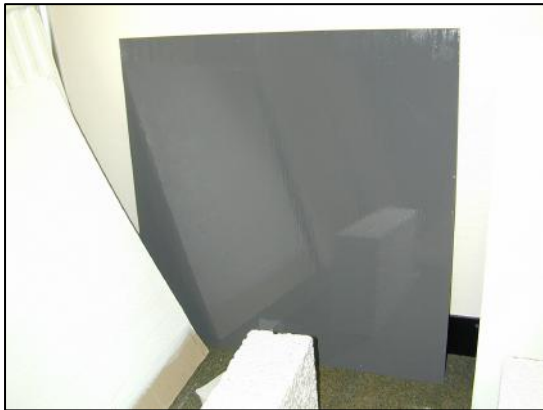
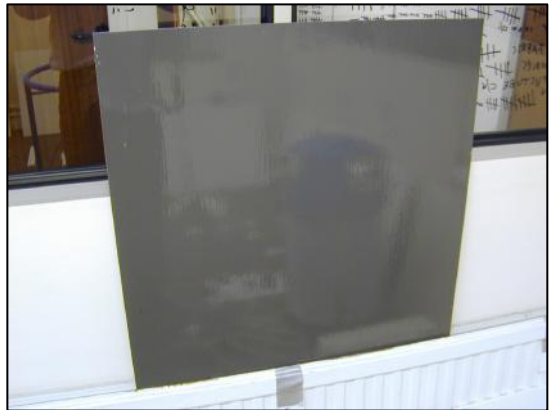
No.4 (mild steel with undercoat, topcoat and varnish) before and after gassing

No bubbling was witnessed on this substrate / paint combination

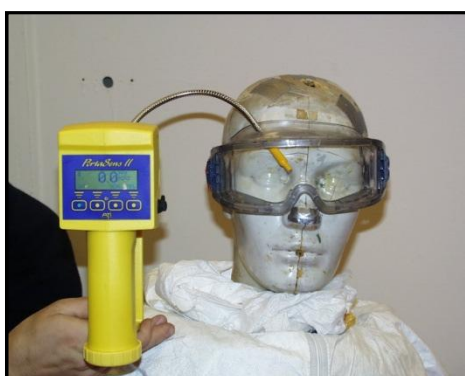
Out-gassing measurement
taken from eye goggles in
position of normal use

The second set of tests showed that the goggles required additional aeration to the standard gassing cycle to ensure that out gassing is minimised. It is recommended that a procedure be developed to aerate the goggles in the safety cabinet for a time after the gassing cycle has been completed.
